Paving and Hard-landscaping Consultancy

Stain testing of Hansebeton paving samples

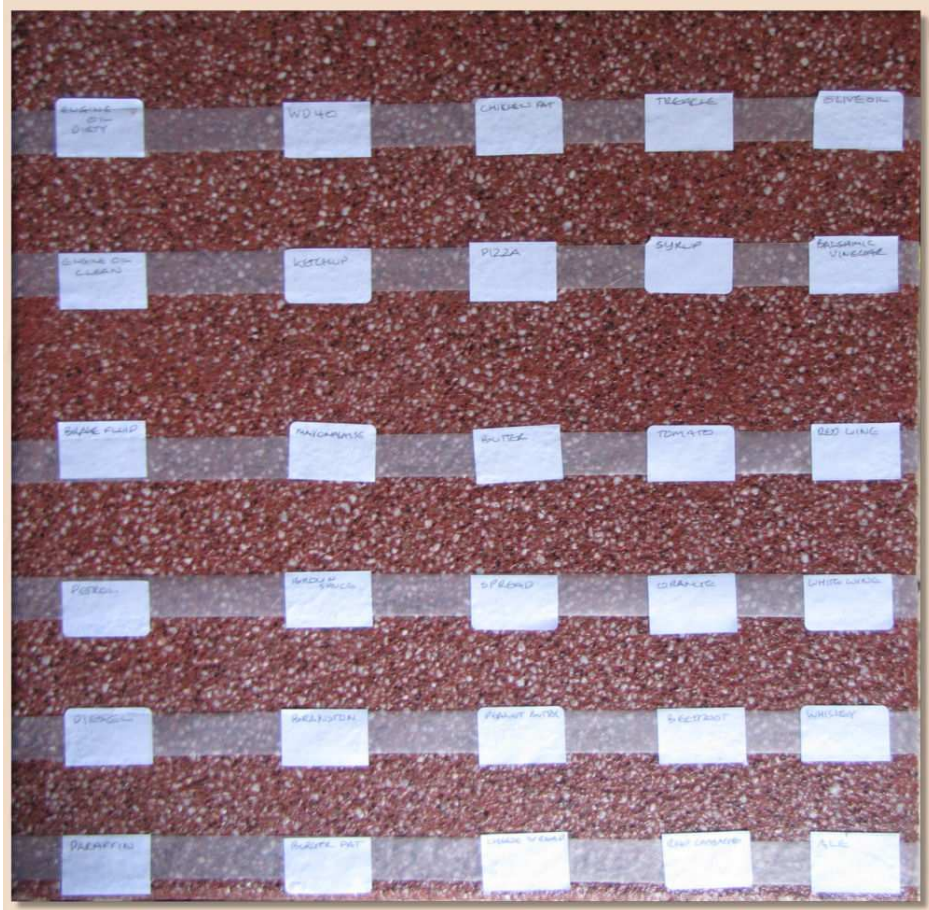
Figure 1 - Tape used to affix labels to flag samples

- 2.3.1 It should be noted that affixing a label to the surface of the flagstones proved to be quite difficult as most self-adhesive labels would not adhere to the surface. Following attempts with a range of proprietary label, it was found that the most effective method of labelling was to use a length of Scotch adhesive tape stretched from the left-hand unsealed edge face to the right-hand unsealed edge face, with labels attached directly to the tape. The tape was able to adhere to the bare concrete on each edge face although there was minimal, if any adhesion to the flag surface. See Figure 1

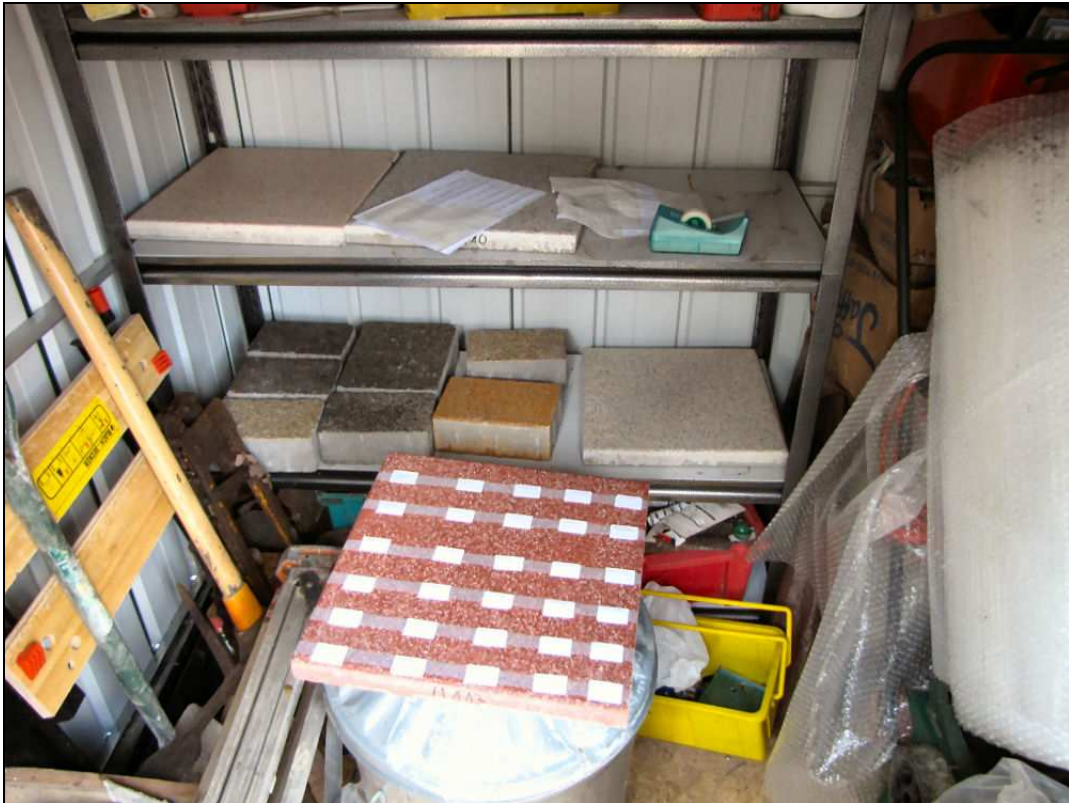
Figure 2 - Steel shelving used to store flags during testing

- 2.4 The flagstone was placed onto a level shelf within a steel racking system within a fully enclosed steel shed (Figure 2). A small quantity of each potential stain was then placed onto its allotted space. Care was taken with the liquids to prevent cross-contamination due to run-off (Figure 3).
- 2.5 Once prepared, the flags were left on the shelf for the prescribed period of time, with the shed doors closed to prevent contamination or disturbance from animals.
- 2.6 The 12 hour tests were undertaken first. On completion of the test period, the flags were removed from the shelf, photographed, cleaned, re-photographed and then set-up for the 3 day test. This procedure was repeated prior to the 7 days tests.

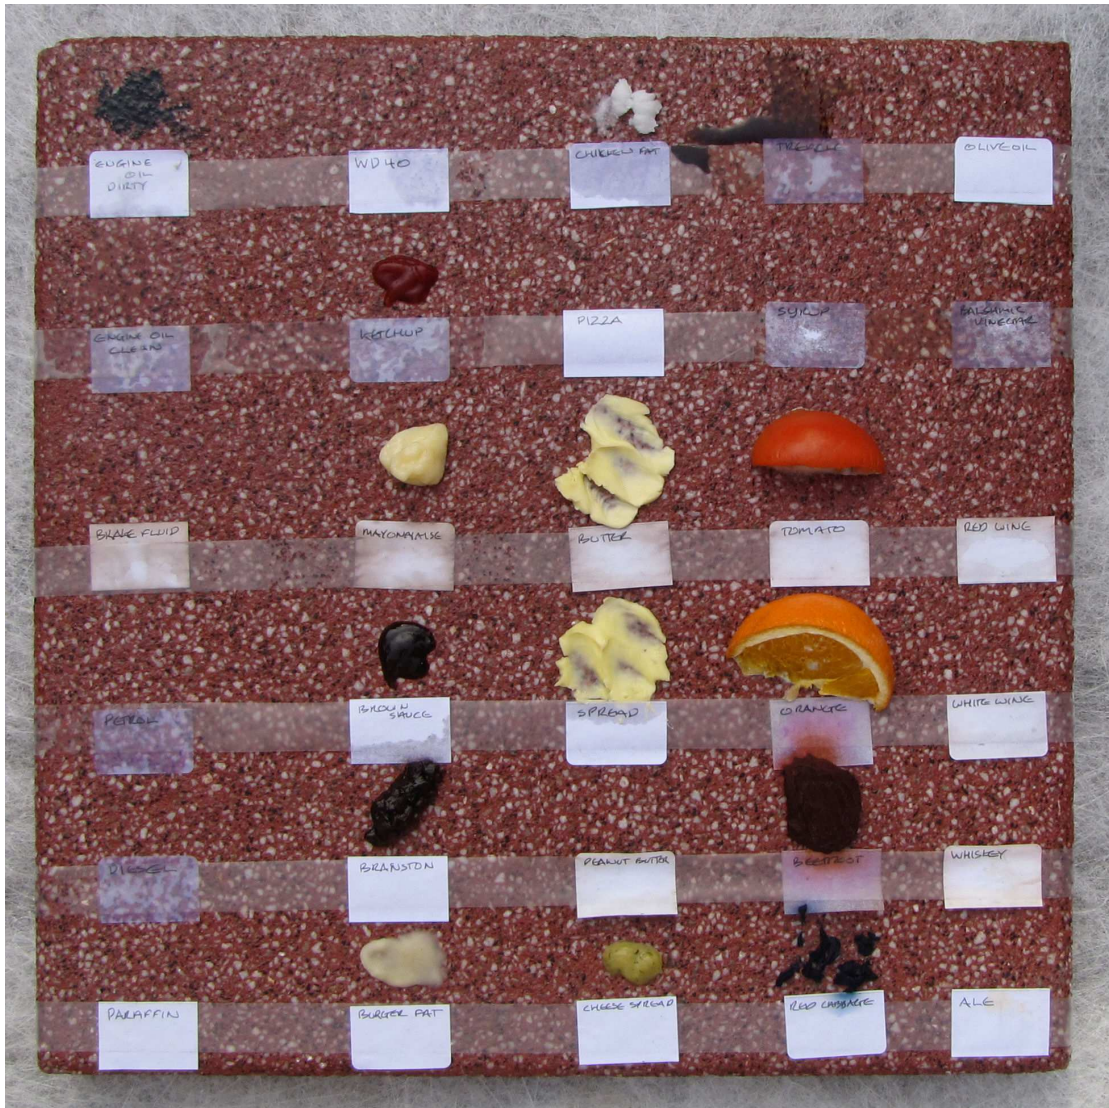
Figure 3 - stains in place on flagstone

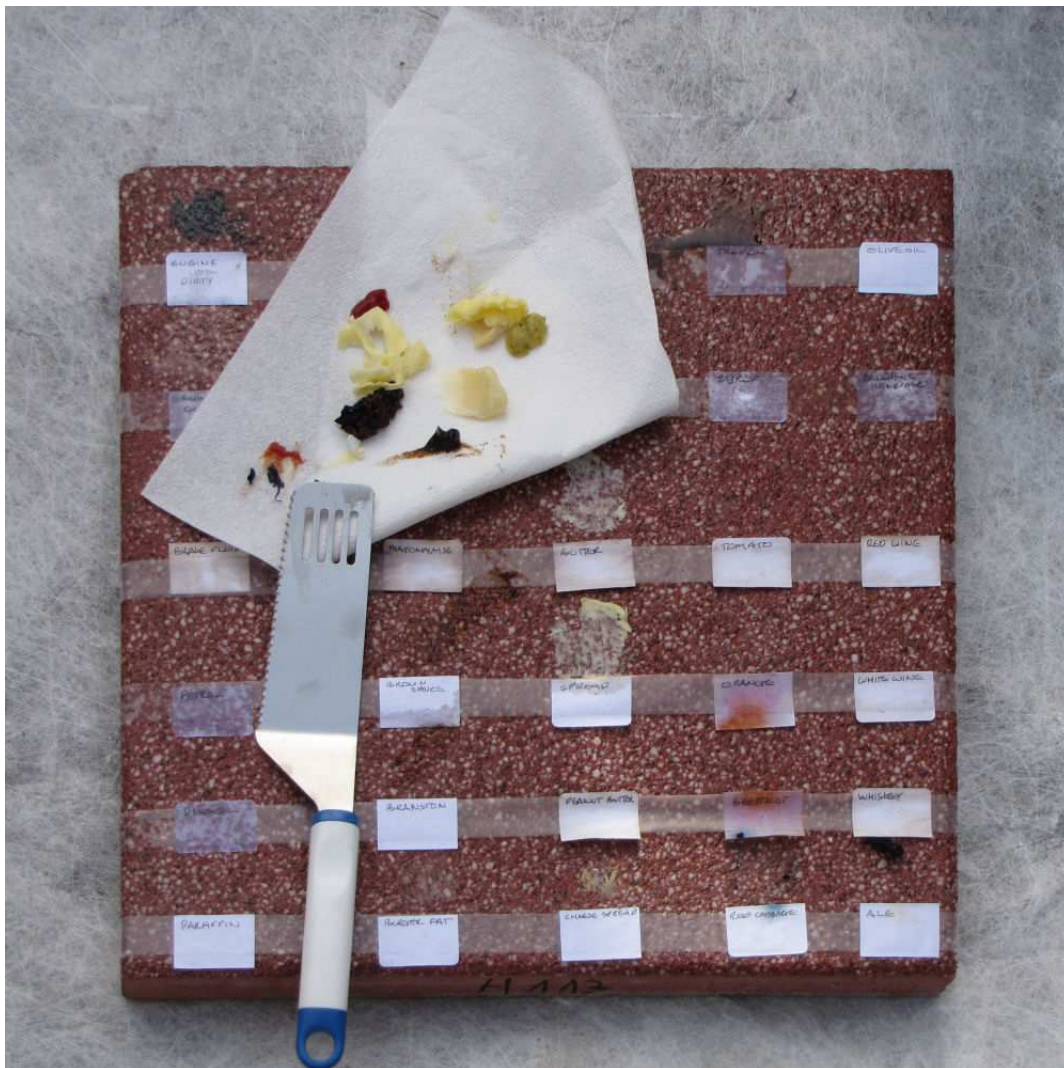
Figure 4 - Residual stain material removed using spatula

- 3.1 Once the test period was completed, the flags were removed from the shelf within the shed, and any remaining product was removed from the surface of the flag by means of a steel spatula (Figure 4).

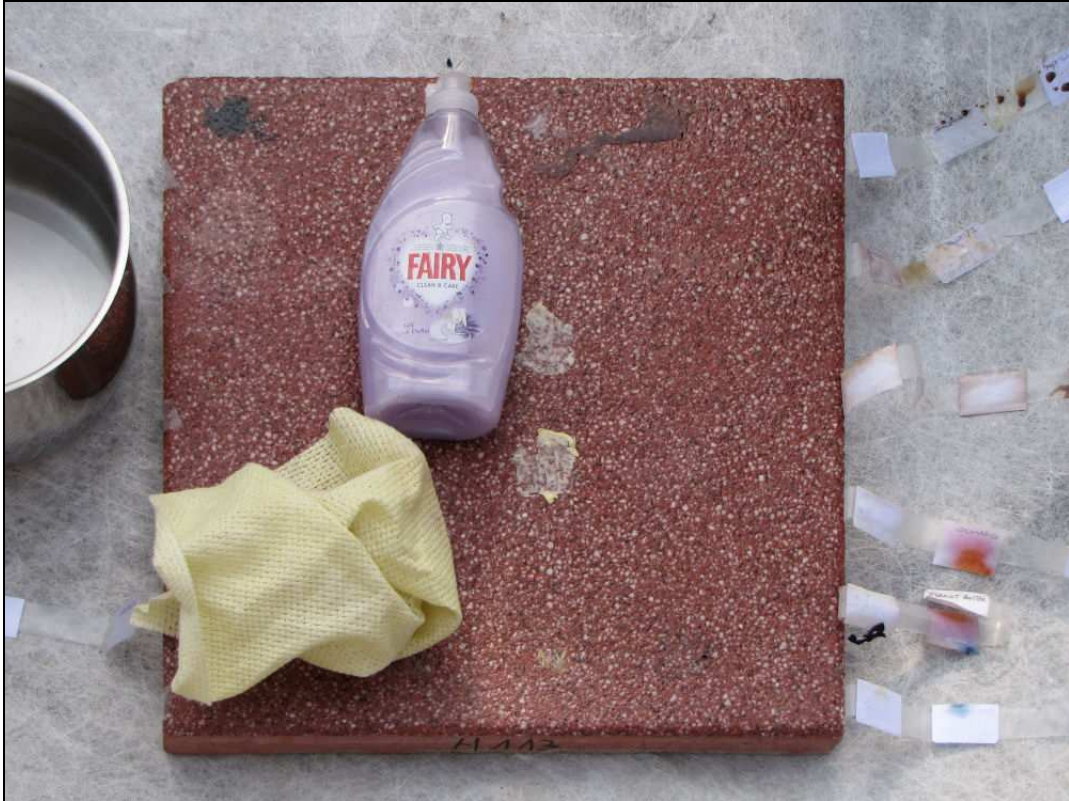
Figure 5 - Initial cleaning with warm water and detergent
Note how label strips have had to be peeled off and placed to one side

- 3.2 The labels were at risk of being dislodged or lost in the cleaning process, and so each horizontal 'strip' of labels was peeled off and placed to one side. This would allow the label strips to be put back into place once cleaning was complete in order to identify any remaining stains (Figure 5).

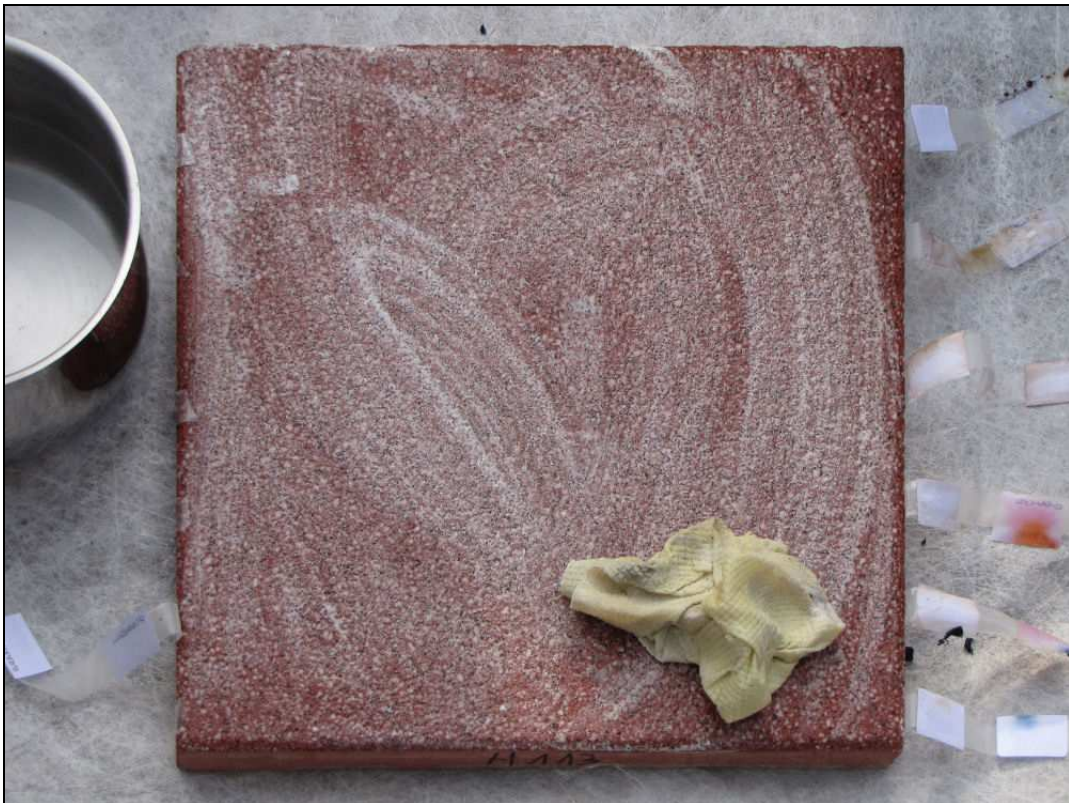
Figure 6 - Cleaning using detergent and water

- 3.3 Once the labels were safely out of the way, the potential stains were wiped using a cotton cloth wetted with warm water and a typical wash-up detergent (Figure 6) and then rinsed with cold water (Figure 7).

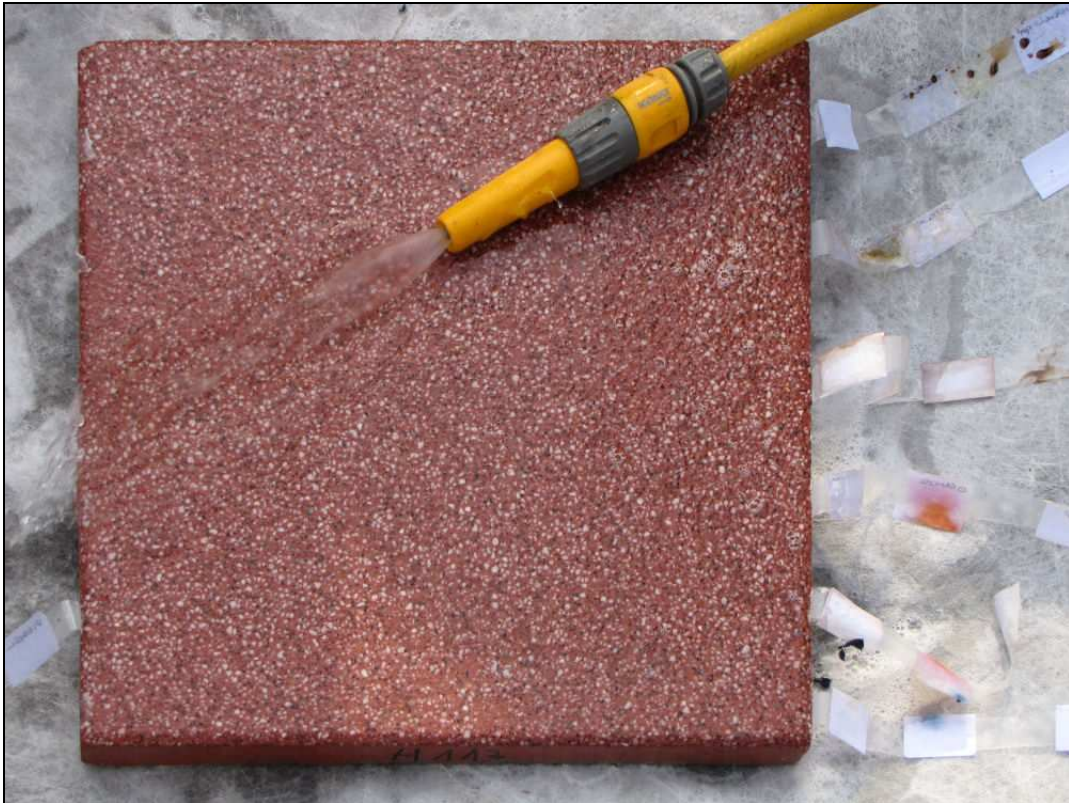
Figure 7 - Rinsing with cold water

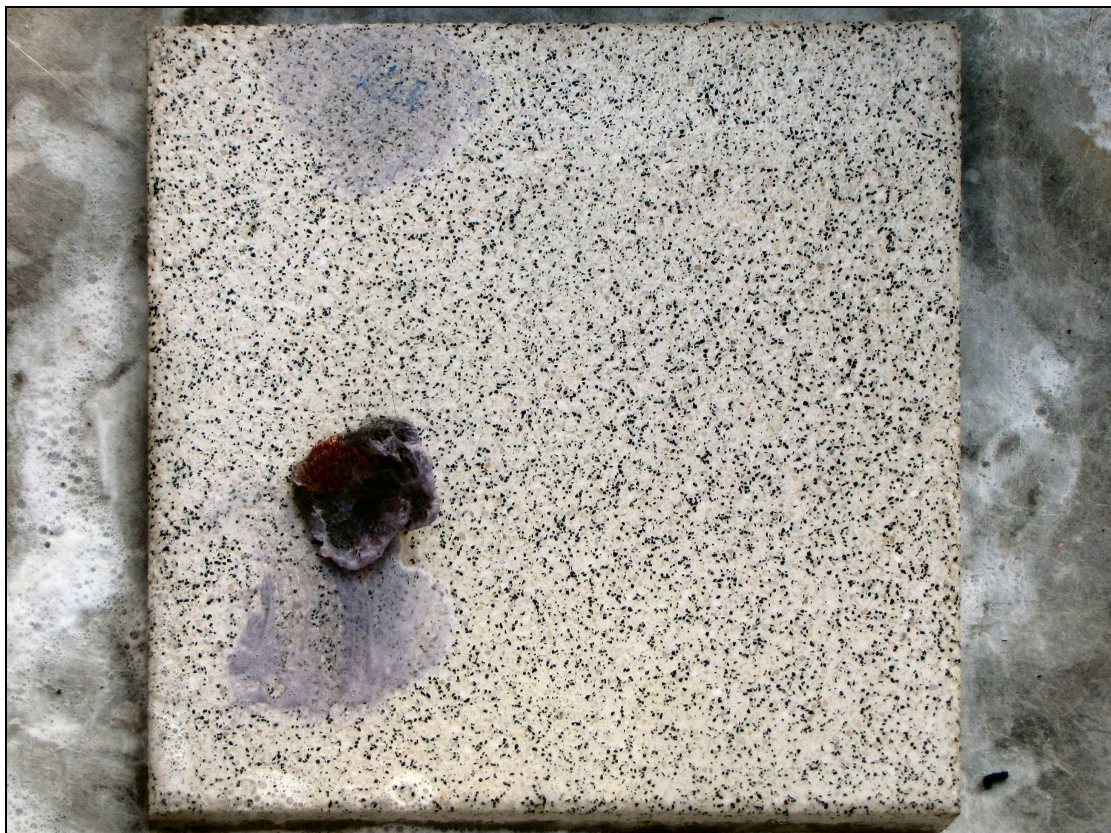
Figure 8 - Cleaning difficult stains with a wire-wool scourer

- 3.4 Any samples that required further cleaning were identified, photographed and then re-cleaned using detergent and a plastic scouring pad. Stains not removed by the plastic scourer were then cleaned using a soap-filled wire-wool scouring pad (Brillo Pad). When this failed to clean off the residual product, the flag was declared stained.

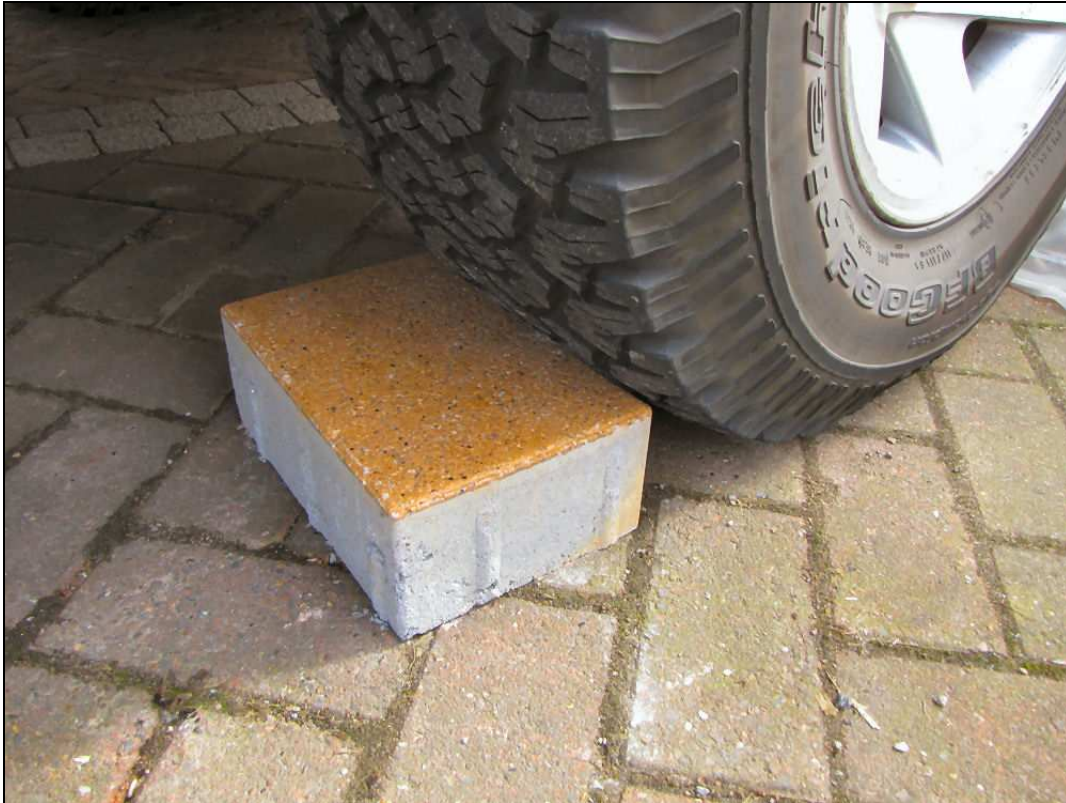
Figure 9 - Trafficking test on 80mm Trento Block Paver

- 4.1 Two paving samples were selected to be tested for tyre marking. The first sample, a 400x400x40mm Domino Facette flagstone in White Rosso (H117) was laid onto an existing driveway surface where it would be repeatedly driven over by a VW Polo. The second sample, a 240x160x80mm Trento block paver in Yellow, was set up in the same manner but was to be trafficked by a heavy 4x4 vehicle, a Mitsubishi L200 (Figure 9).

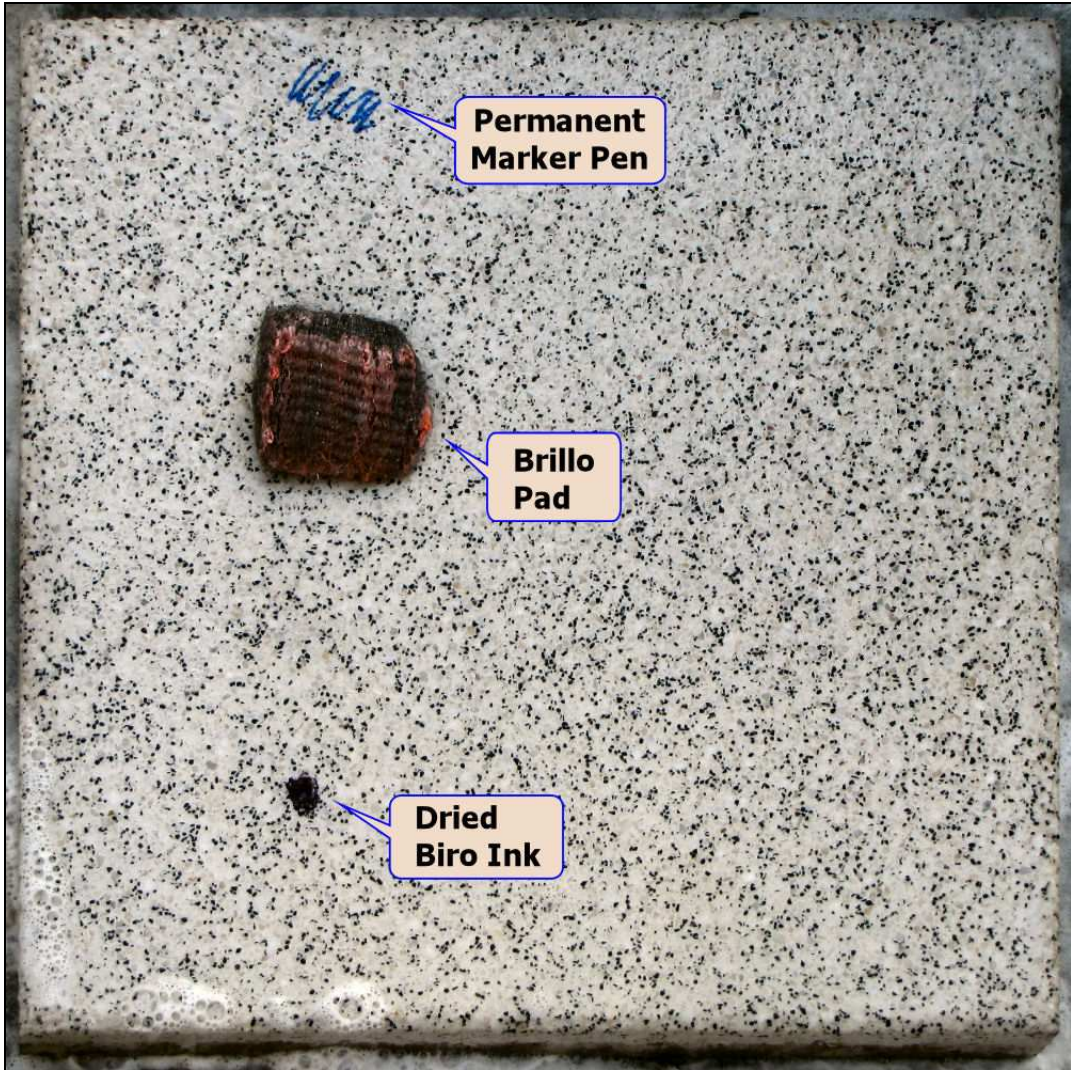
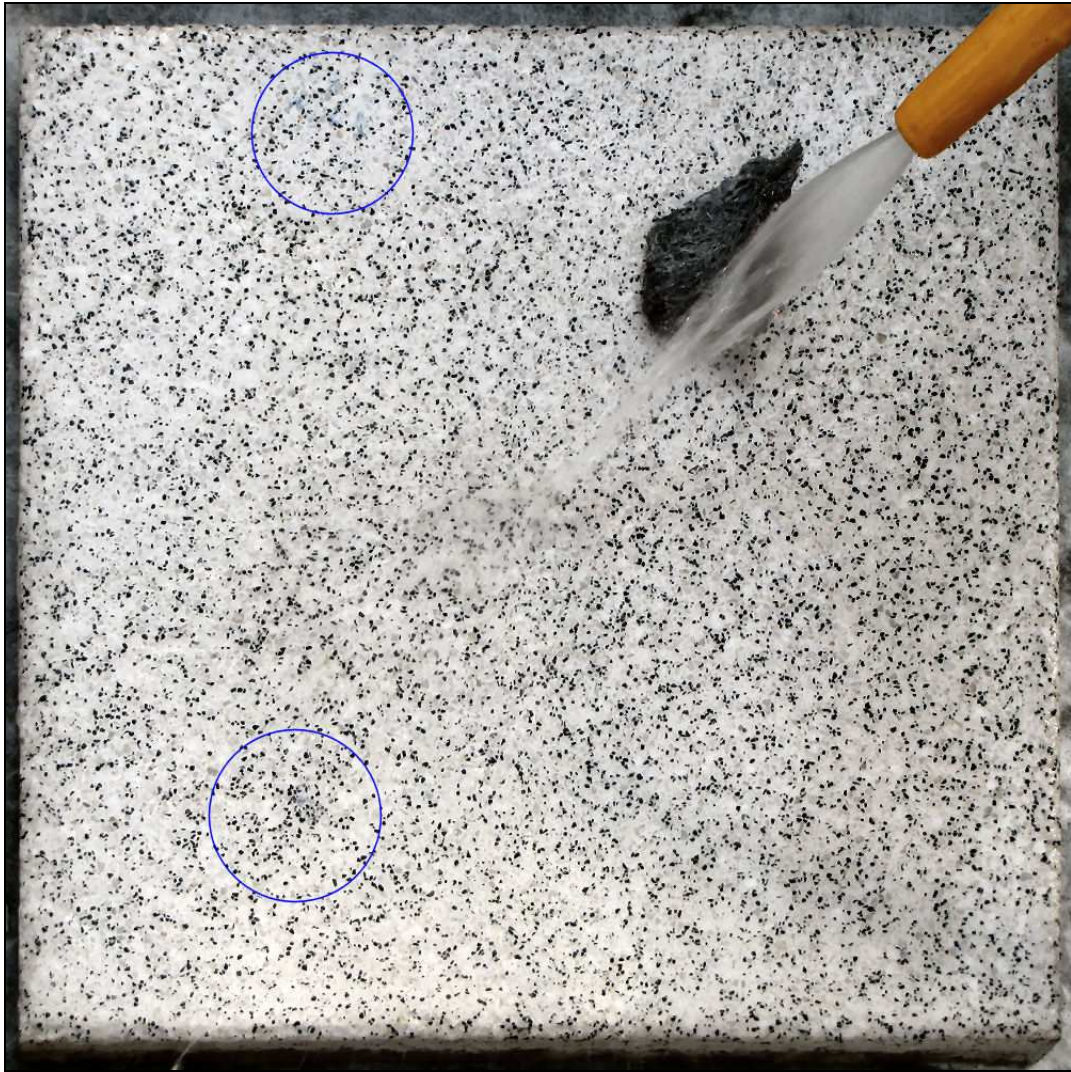
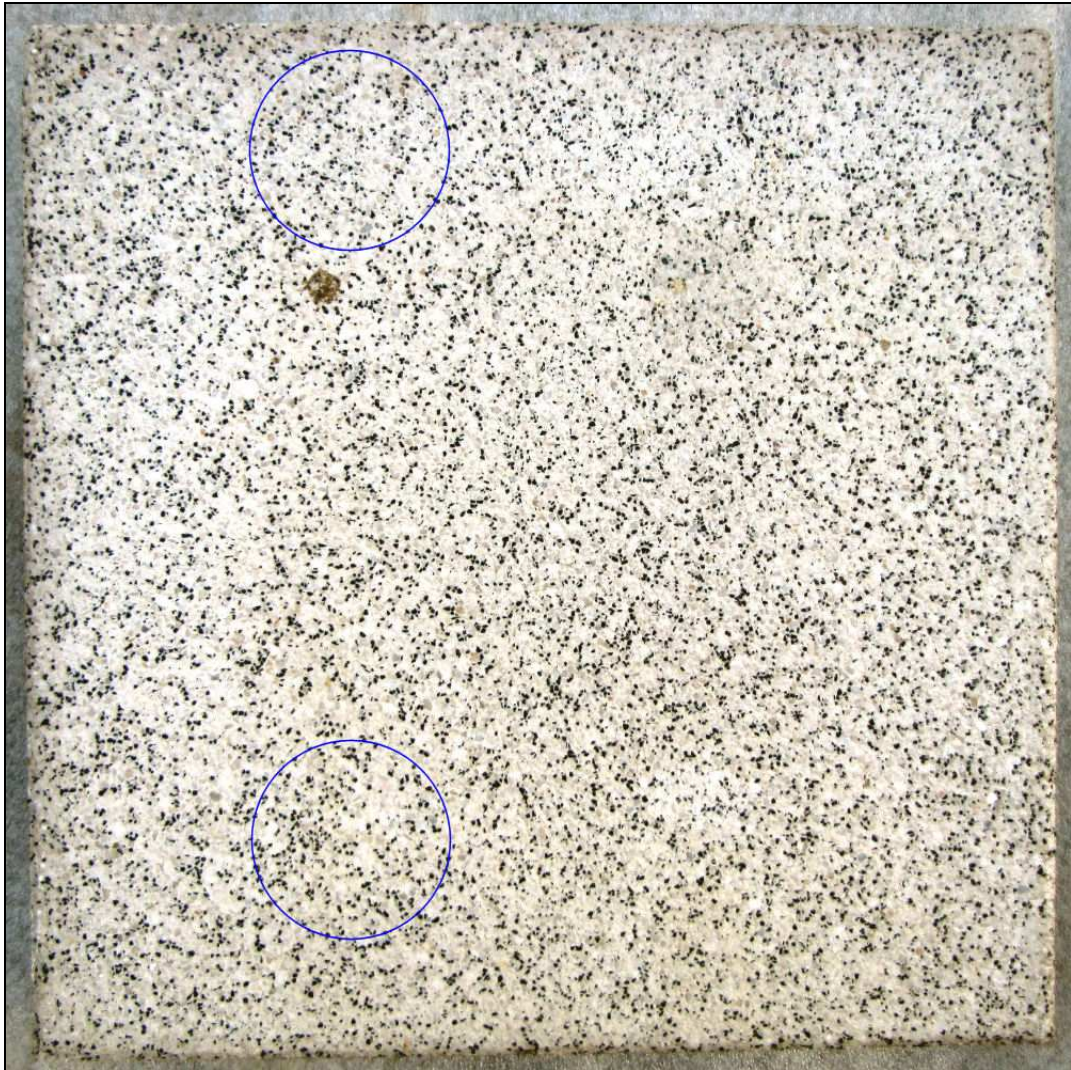
Figure 11 - Marker and ink stain to flag #2

Figure 12 - Stains still faintly visible after first scrubbing

Figure 13 - Stains completely removed
Other marks visible in this image arise for subsequent testing on this flagstone

- 1 Stain not removed by washing with detergent but was completely removed by heavy scrubbing using a soap-filled wire-wool scourer aka a Brillo Pad (See Figures 11-13)
- 2 Ink partially dried but removed using heavy scrubbing with cotton cloth
- 3 Ink dried but removed using Brillo pad (See Figures 11-13)
- 4 A faint green tinge developed in this area and these products were initially suspected of being responsible. Further testing was undertaken and is detailed later in this report
- 5 Slight discolouration or marking of surface
- 6 Damage to surface detectable to finger tip (See Figure 14)
- 7 Distinct damage to surface which seems to have been blistered (See Figure 15)

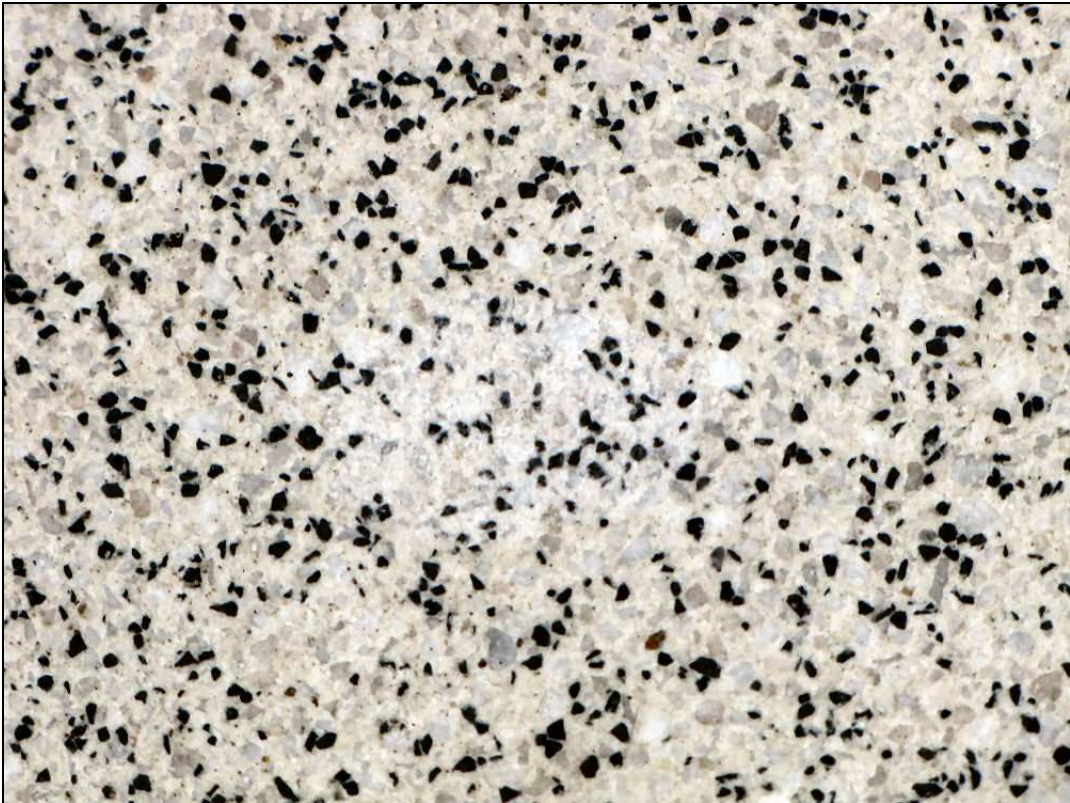
Figure 14 - A faint lightening of the surface where it has been in contact with paint stripper for 3 days

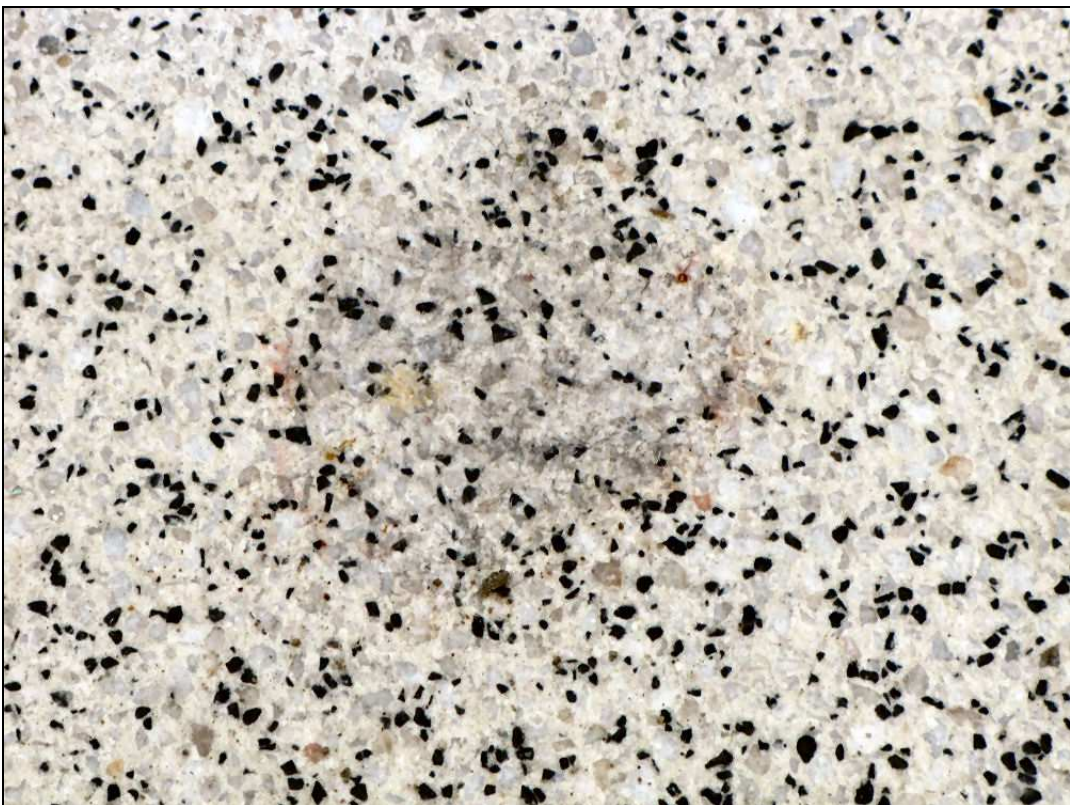
Figure 15 - Distinct damage to surface after 7 days in contact with paint stripper

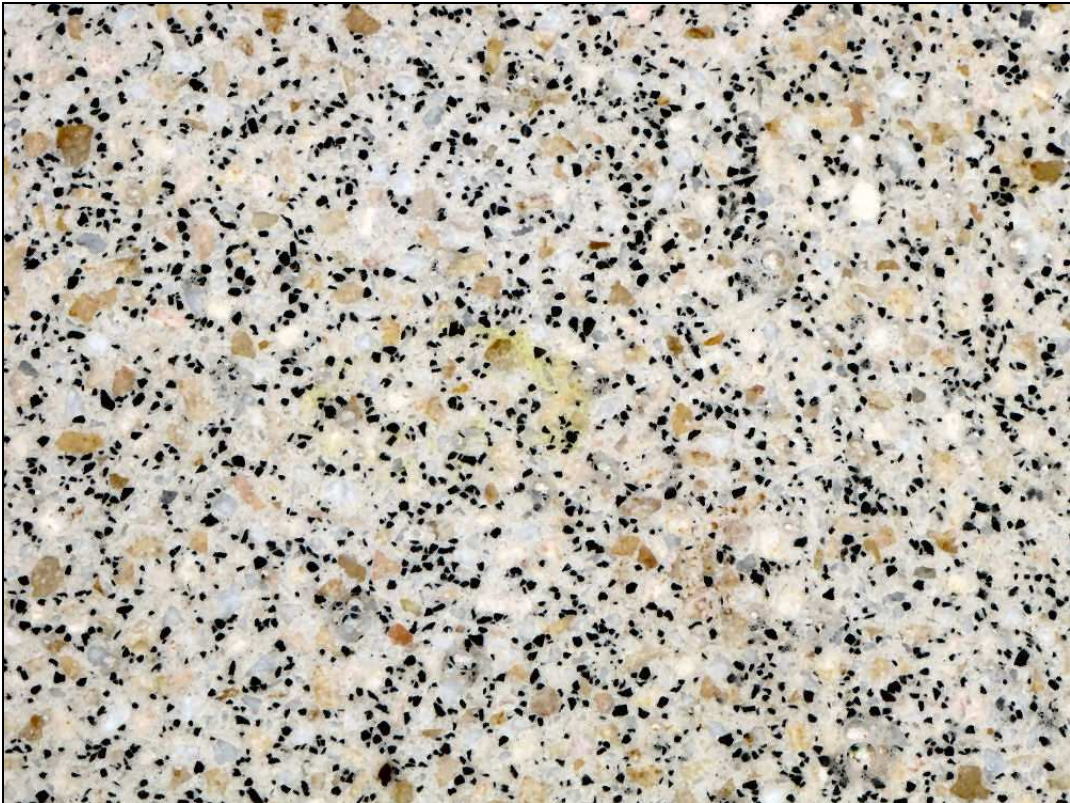
Figure 17 - Faint staining from mustard was cleaned by scrubbing

- 8 A faint yellow stain was detected but was removed by heavy scrubbing with cloth and detergent (See Figures 17 and 26)
- 9 A faint rust like stain was detected but was removed by scrubbing with a wet cloth and detergent
- 10 A distinct stain was apparent. It was removed by light scrubbing with a Brillo pad but further testing was deemed necessary
- 11 Definite and permanent stain (See Figures 18 and 26)
- 12 A cigarette was lit and allowed to burn down while lying on the flagstone. Although light tar deposits were initially visible, these were easily removed using a damp cloth with detergent, and there was no discernible damage to the surface of the flagstone. See Figures 19-25

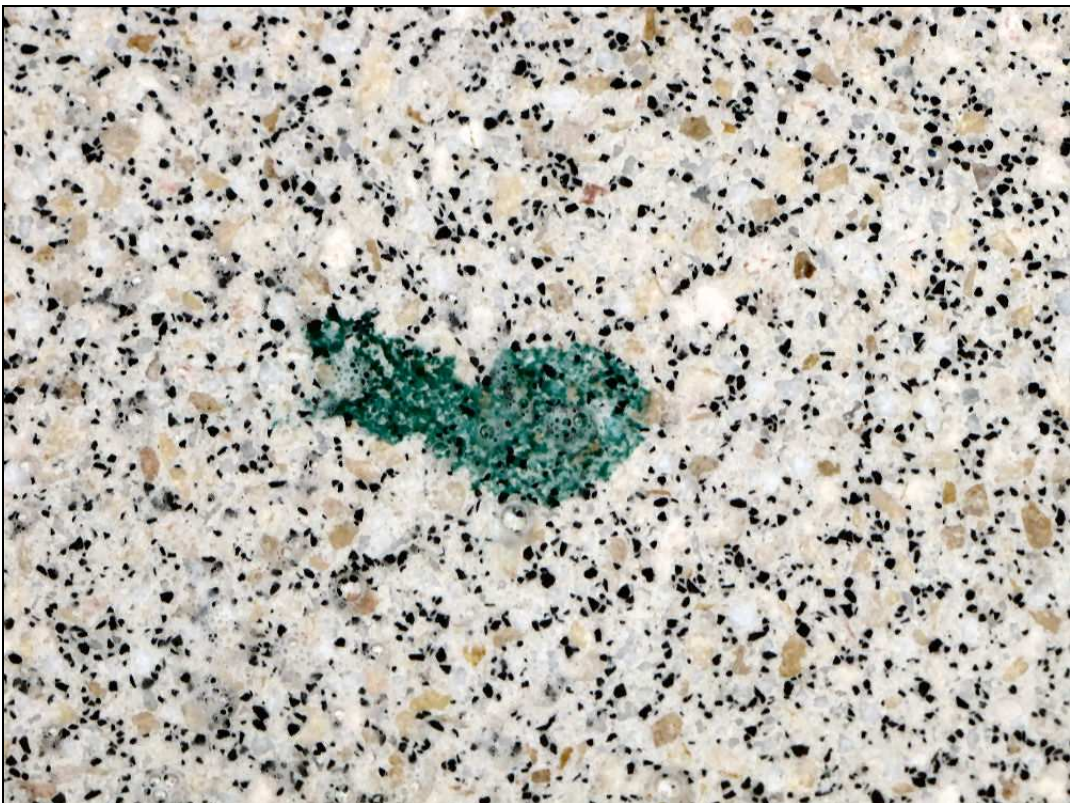
Figure 18 - Permanent staining caused by timber preservative

- 6.1 No surface can be completely stain-proof, as there are products that are intended to stain. This is shown quite clearly by the timber preservative used in the stain tests on Flag #3. Indeed, it could have been considered a failure of the timber preservative had it been unable to impart a permanent stain.

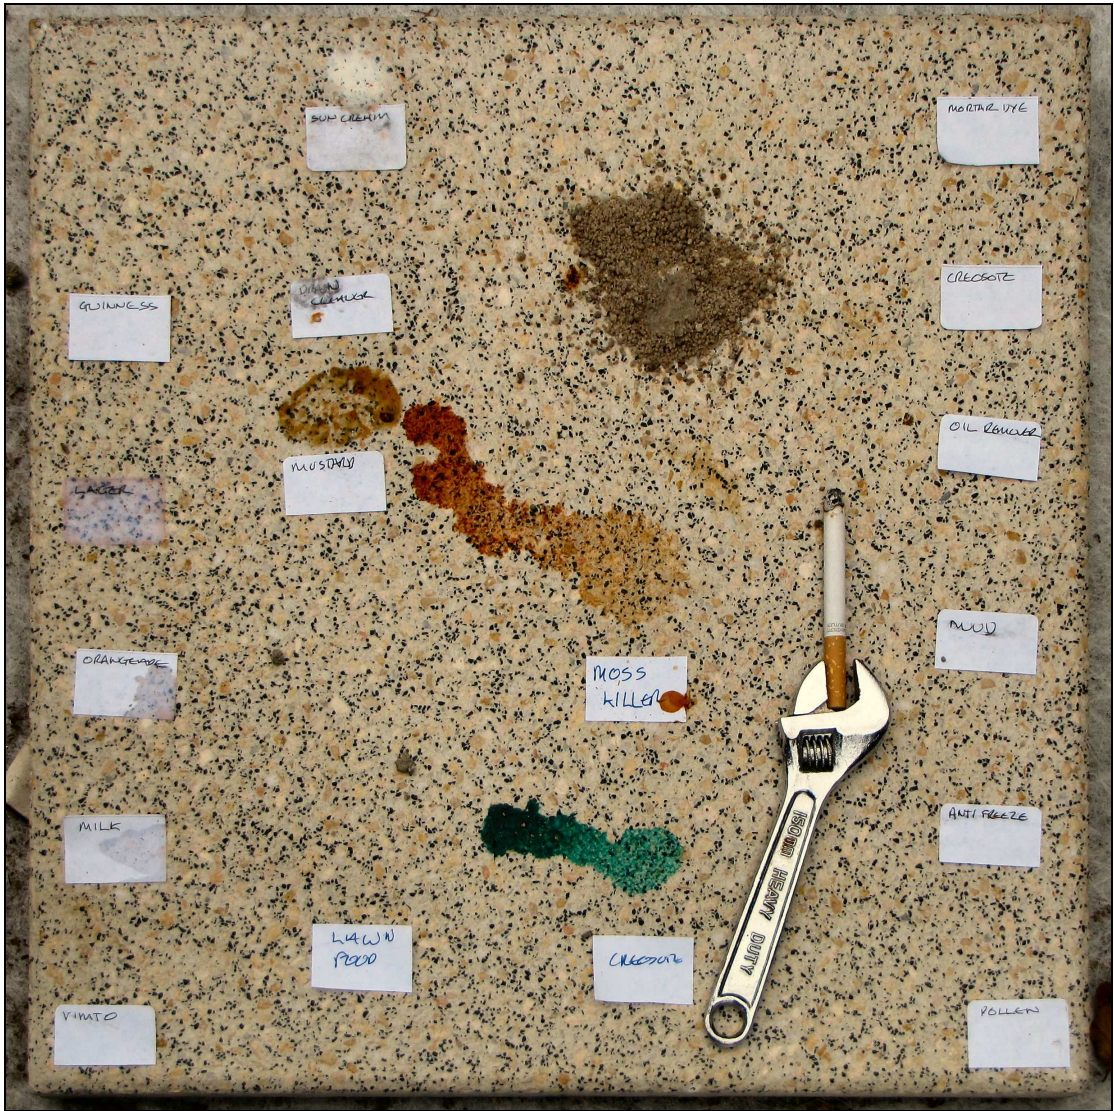
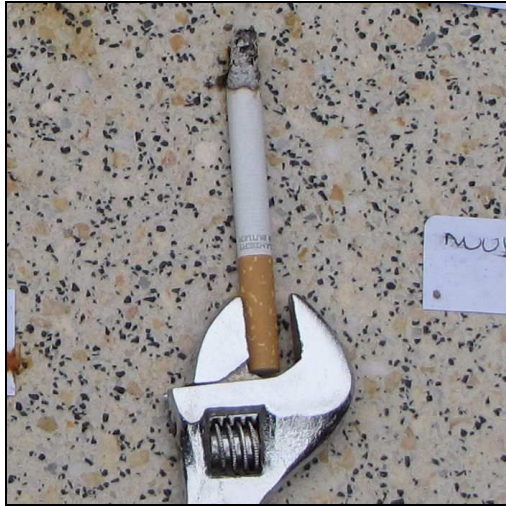
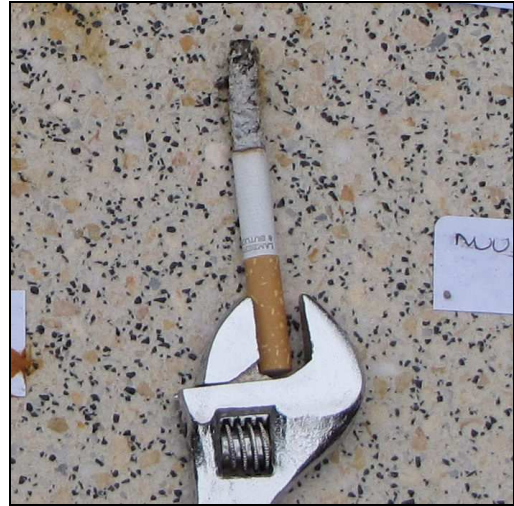
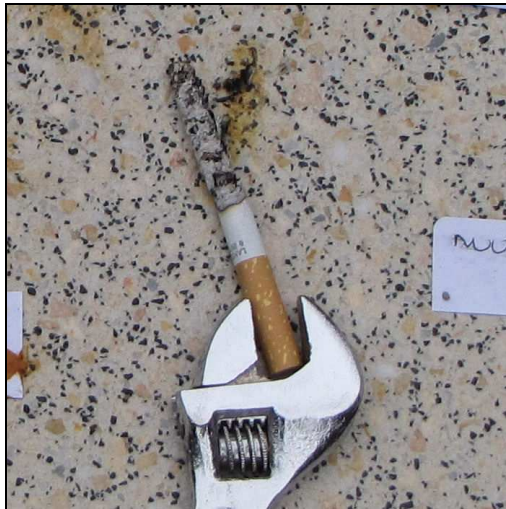
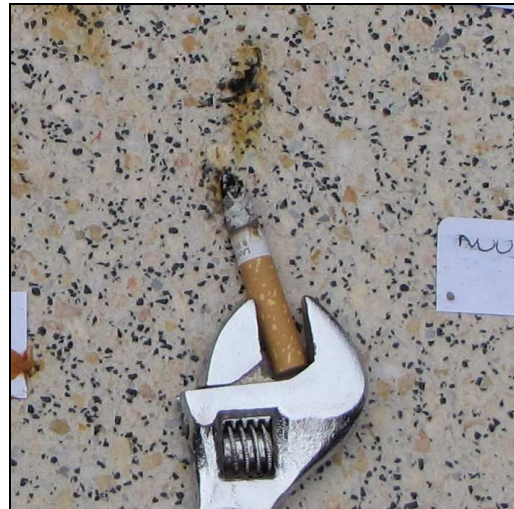
Figure 19 - Cigarette testing on Flag 3

Figure 20 - Cigarette test

- 6.5 The cigarette test suggested that the sealant is capable of coping with high temperatures, but the one-off test undertaken here can not realistically be taken as conclusive proof of heat-resistance.

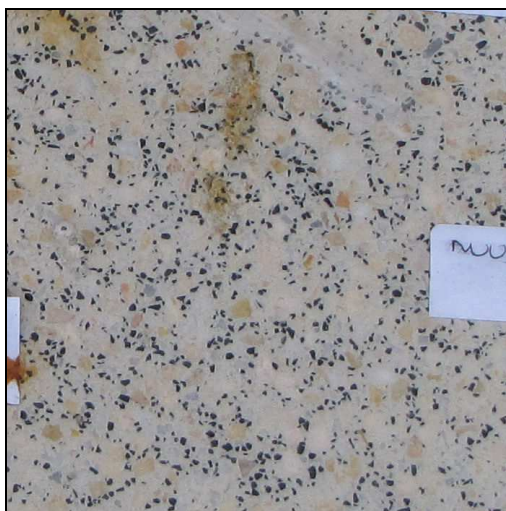
Figure 24 - Tar residue is washed off

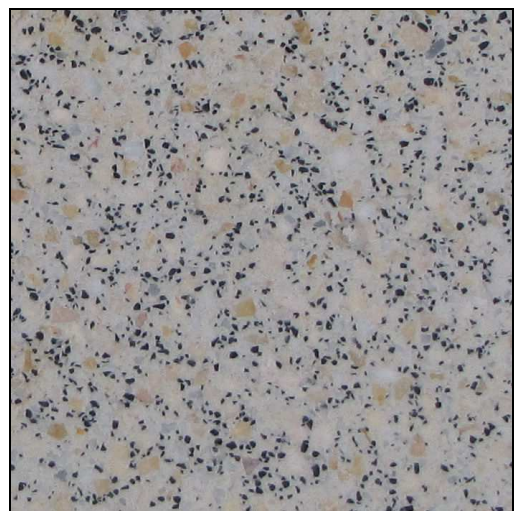
Figure 25 - No discernible stain or burn marks

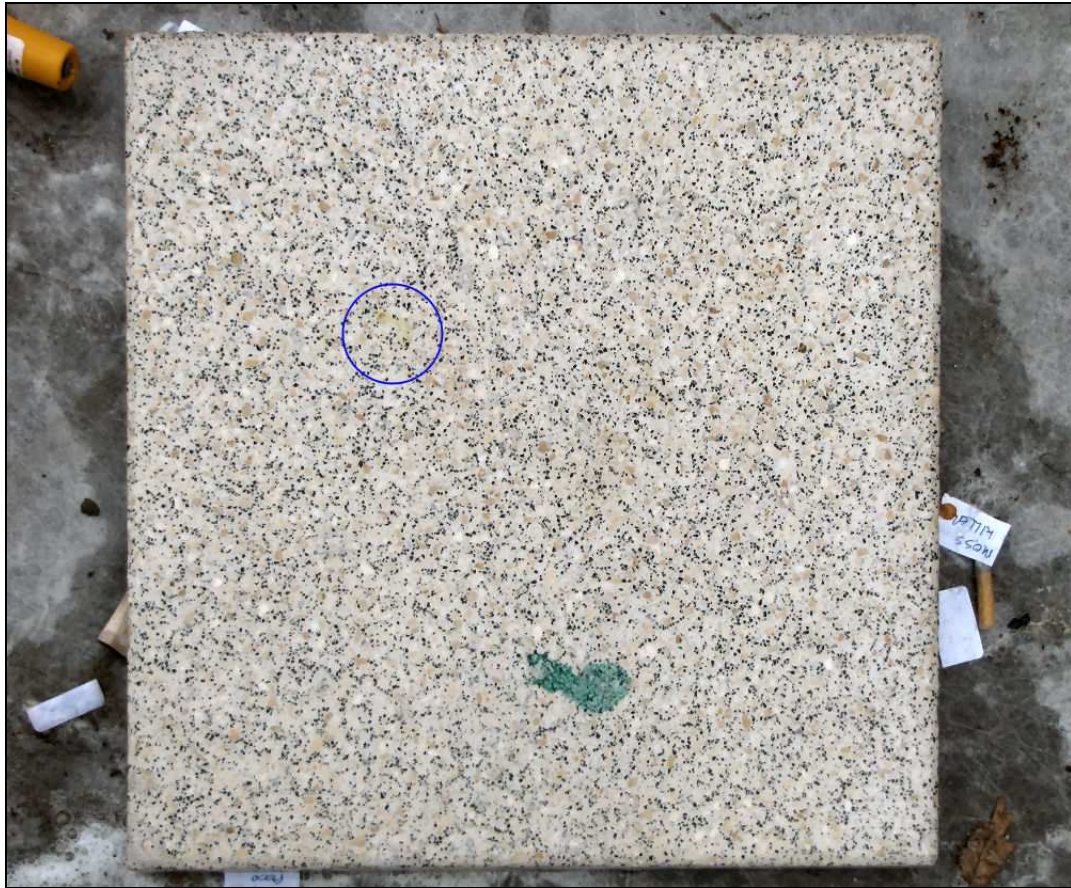
Figure 26 - Flag 3 after cleaning. Faint mustard stain is highlighted in blue circle

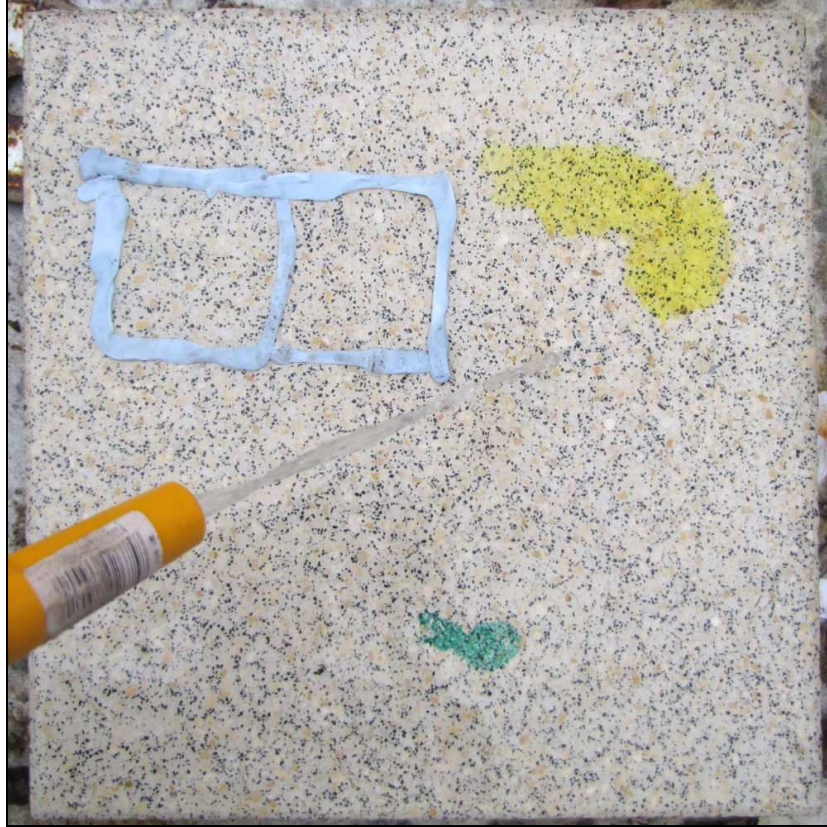
Figure 28 - Washing off re-test stains

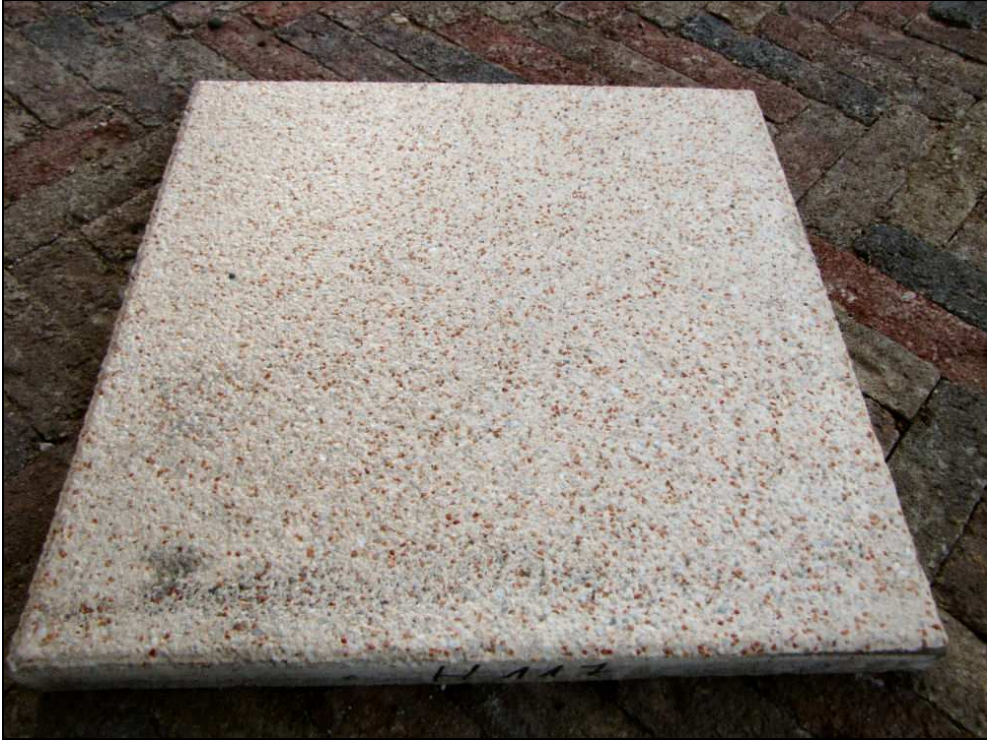
Figure 30 - Flag after 100 passes

- 5.7.1 The flag trafficked by the small car showed faint marking after 100 passes (Figure 30) and by the end of the test, with 500 passes completed over a period of 4 weeks, the flags was distinctly marked (Figure 31). The light colouring of the flagstone emphasised the black tyre marks and there were very distinct marks along the arris of the flagstone where the sealed top surface meets the unsealed concrete of the edge face.
