Paving and Hard-landscaping Consultancy

Stain testing of Hansebeton paving samples

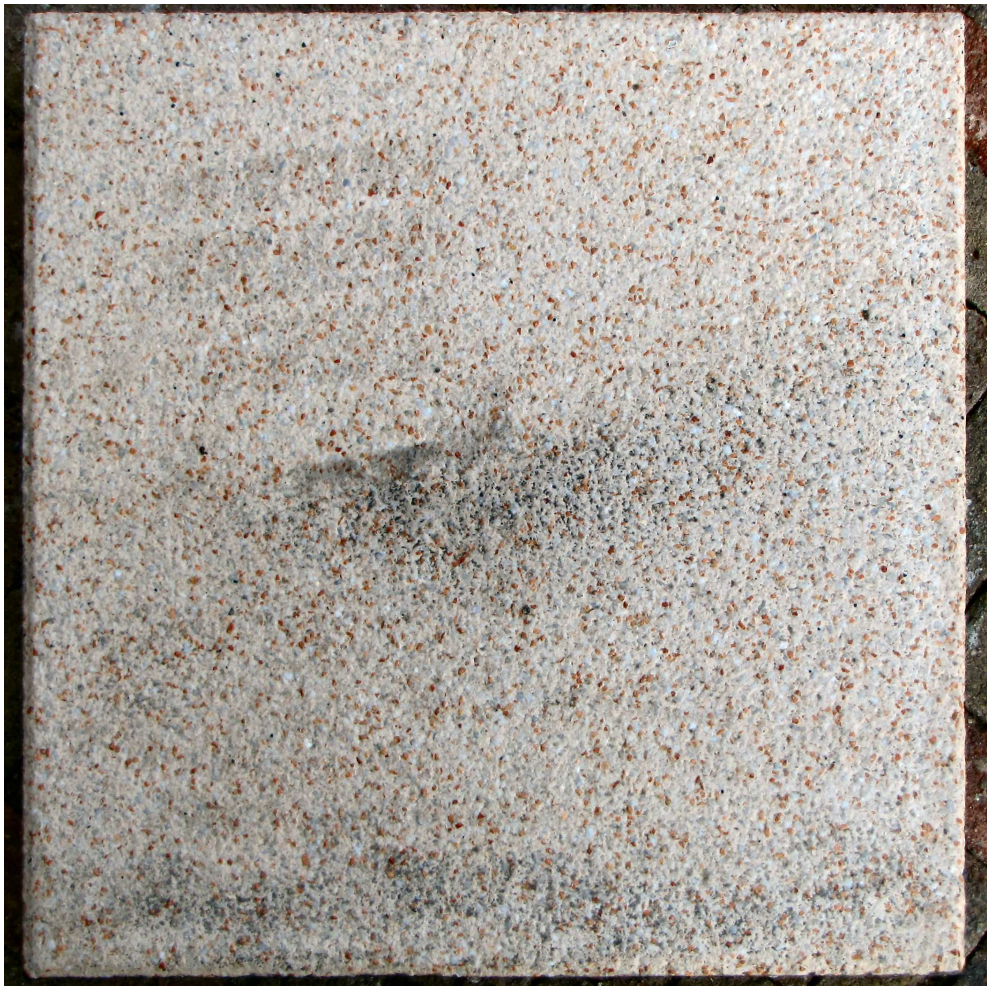
Figure 31 - Flag after 500 passes

- 5.7.1 The flag trafficked by the small car showed faint marking after 100 passes (Figure 30) and by the end of the test, with 500 passes completed over a period of 4 weeks, the flags was distinctly marked (Figure 31). The light colouring of the flagstone emphasised the black tyre marks and there were very distinct marks along the arris of the flagstone where the sealed top surface meets the unsealed concrete of the edge face.

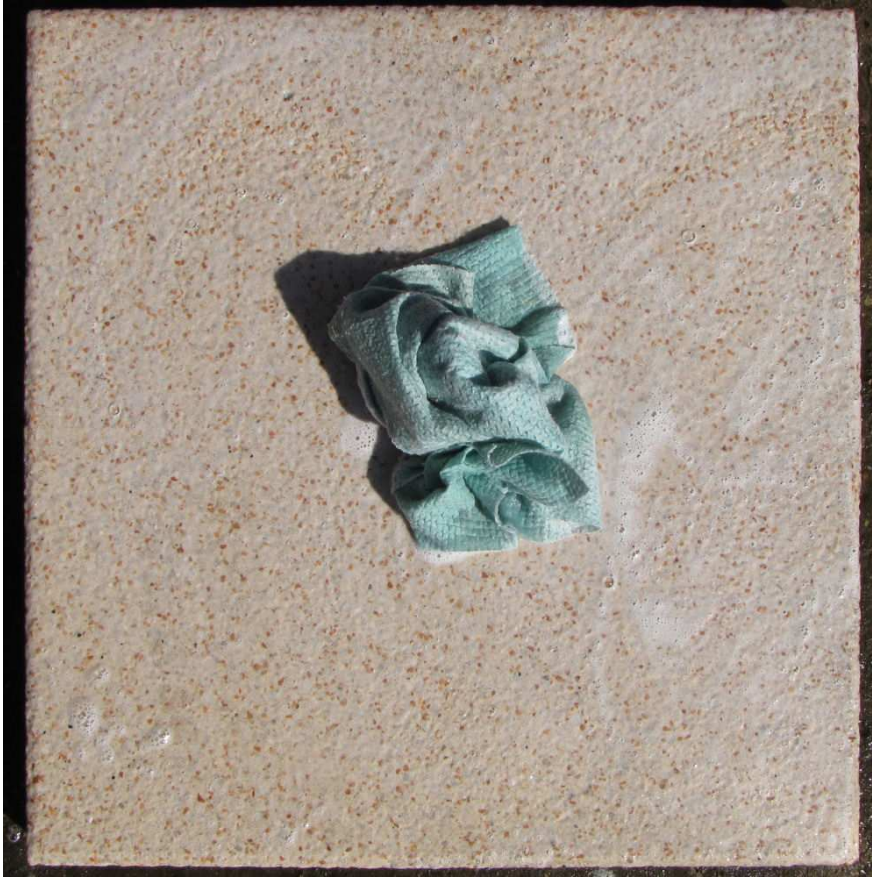
Figure 32 - Cleaning tyre marks using soapy water

- 5.7.3 Both the flagstone and the block were washed down using a cotton cloth with warm water and a small amount of the same wash-up detergent used with the other stain tests and it was surprisingly easy to remove all marks other than those made on the unsealed concrete of the edge faces.

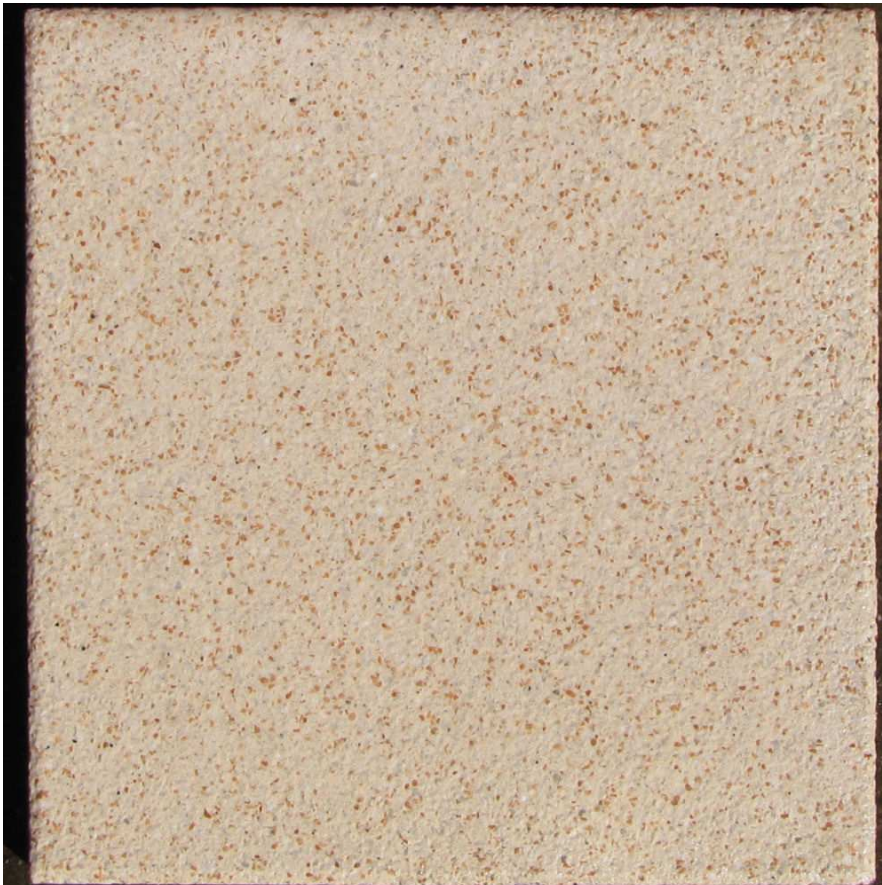
Figure 33 - Cleaned flag after being allowed to dry off

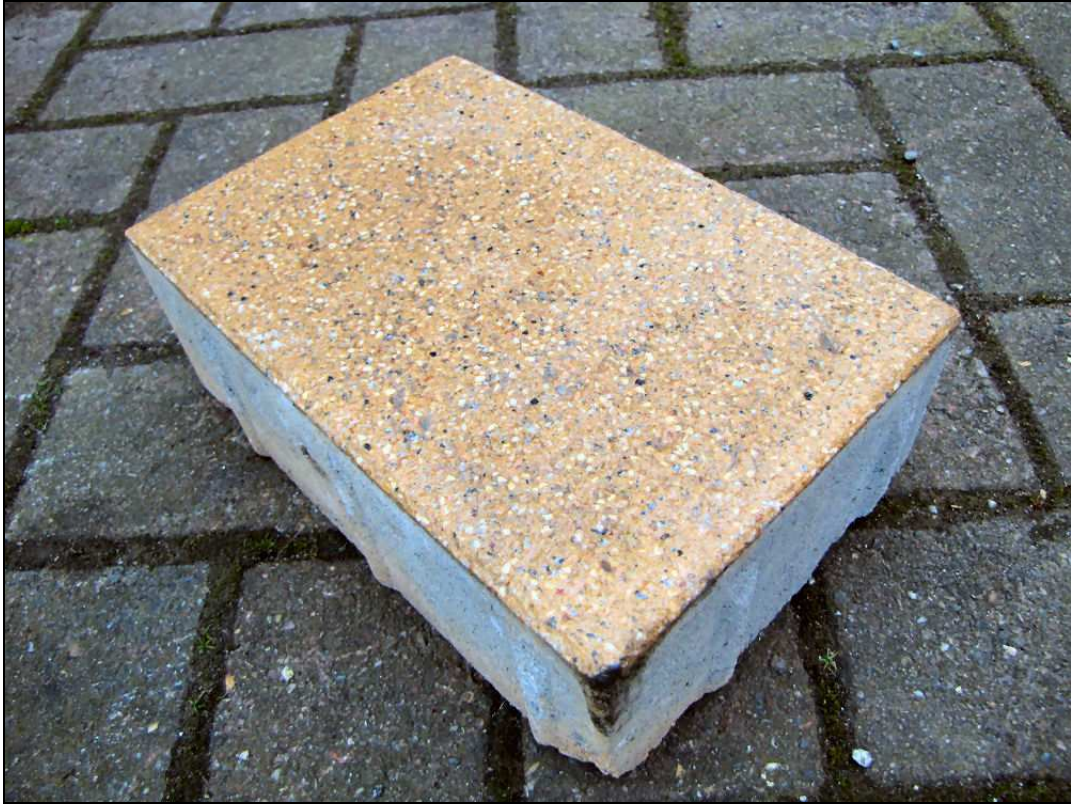
Figure 34 - Block showing tyre marks remaining on arris after cleaning

- 5.7.2 The block trafficked by the heavier 4x4 vehicle showed similar markings although the slightly darker colouring of the block made these less noticeable. Again, there were heavy markings on the arris of the blocks which had been repeatedly 'rubbed' by the tyre as the vehicle mounted the 80mm high block.
